Date: August 13, 2009

Subject: PROGRESS REPORT FOR BIOFILTER TESTING

**HYPERION TREATMENT PLANT (HTP)
BIOLOGICAL ODOR CONTROL TESTING PROJECT
(CIP 2143)
REPORT AS OF JULY 31, 2009**

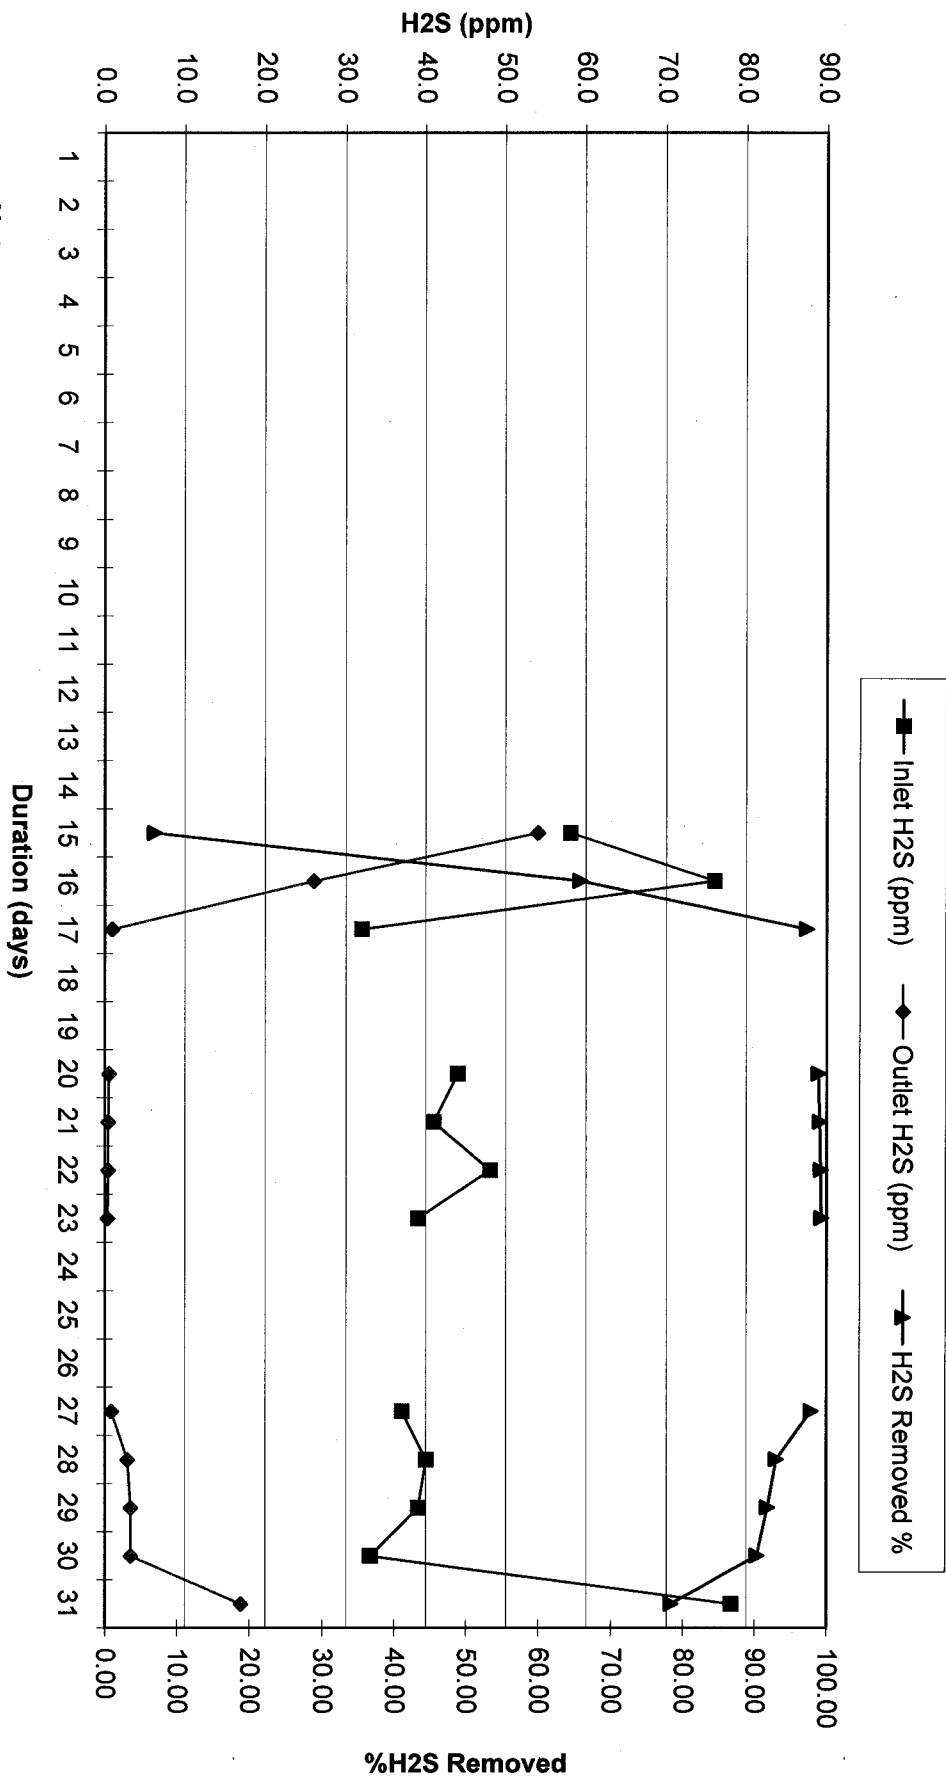
4-Vessels Test Unit - Matala Media July 2009

Note:
 June 29- System was shut down due to excessive water in the area caused by running HPE water during last day.
 July 15- The system was started up after the repair work was completed.

The performance of all there vessels (Matala, Zander and lava rock) reached the optimum level within one week, however the vessels loaded with Matala and lava rock showed a decline during later part of this period.

The performance of all three vessels (Matala, Zander and lava rock) reached the optimum level after one week. However the Matala and lava rock showed a decline during late July. Originally the flow rate for re-circulation system was adjusted for 3.9 gpm for Matala, 2.9 gpm for Zander and 3.9 gpm for lava rock. These set-ups were identified by observing the spray pattern over the top of each vessel. The unstable performance during star-up is common in some units. We will change the operational parameter to improve performance during next period if the deficiencies continue.

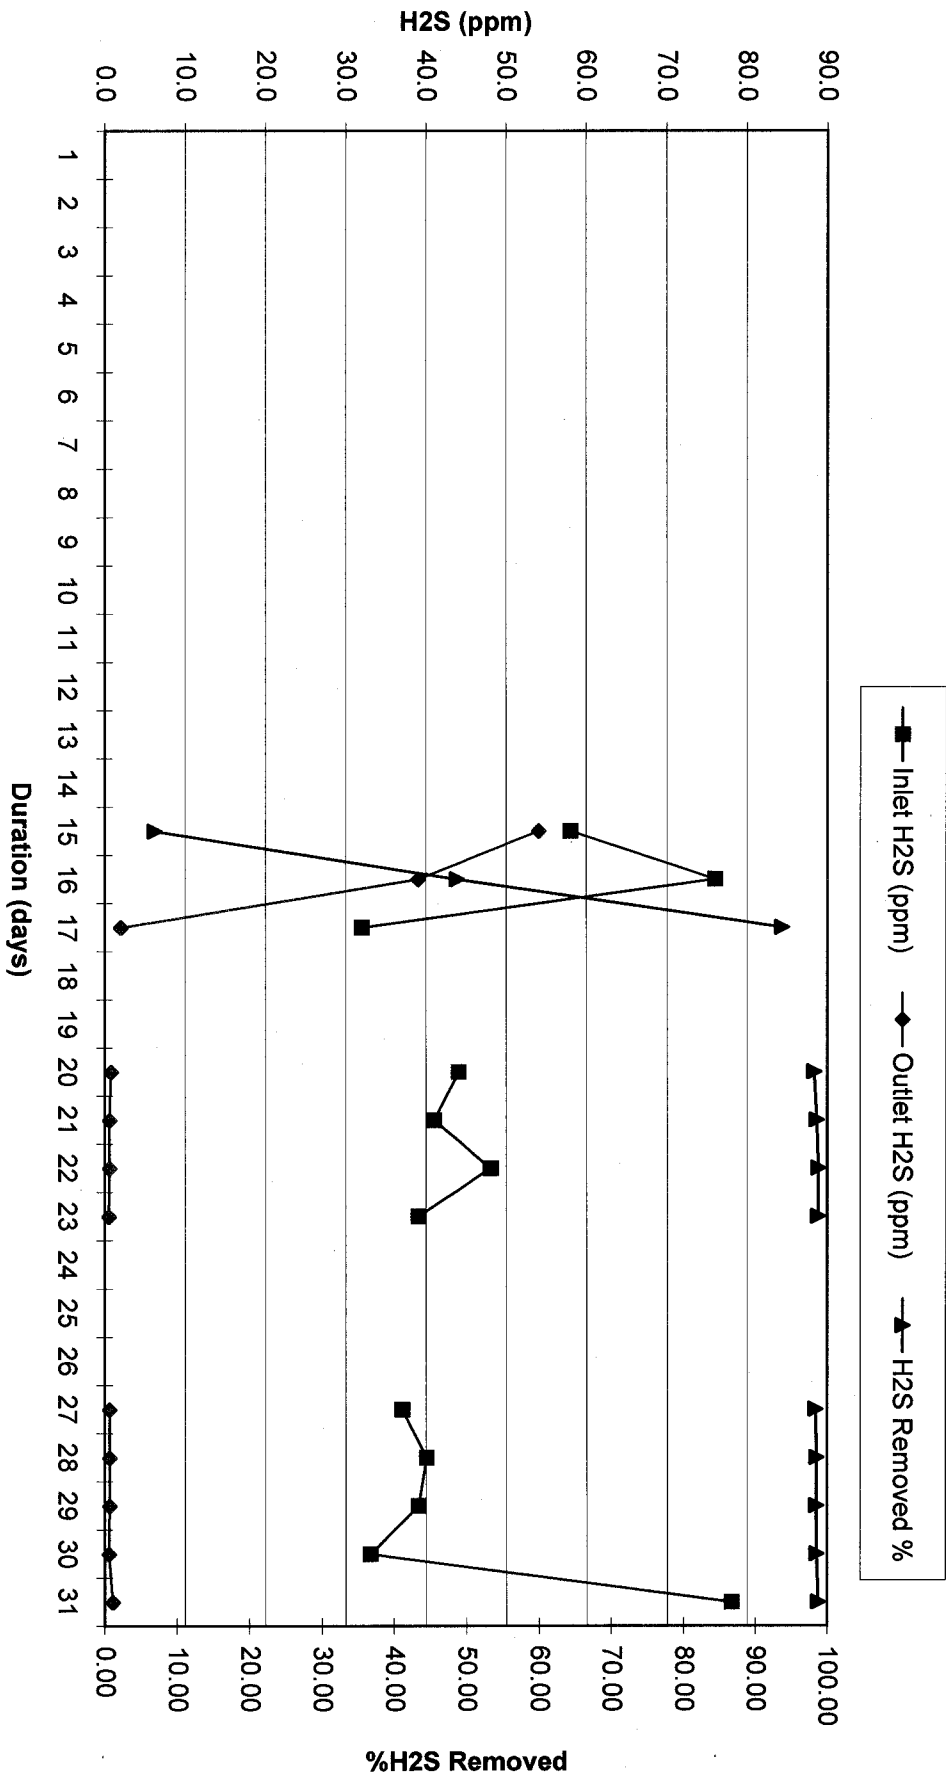
4-Vessels Test Unit - Zander Media July 2009

Note:
 June 29- System was shut down due to excessive water in the area caused by running HPE water during last day.
 July 15- The system was started up after the repair work was completed.

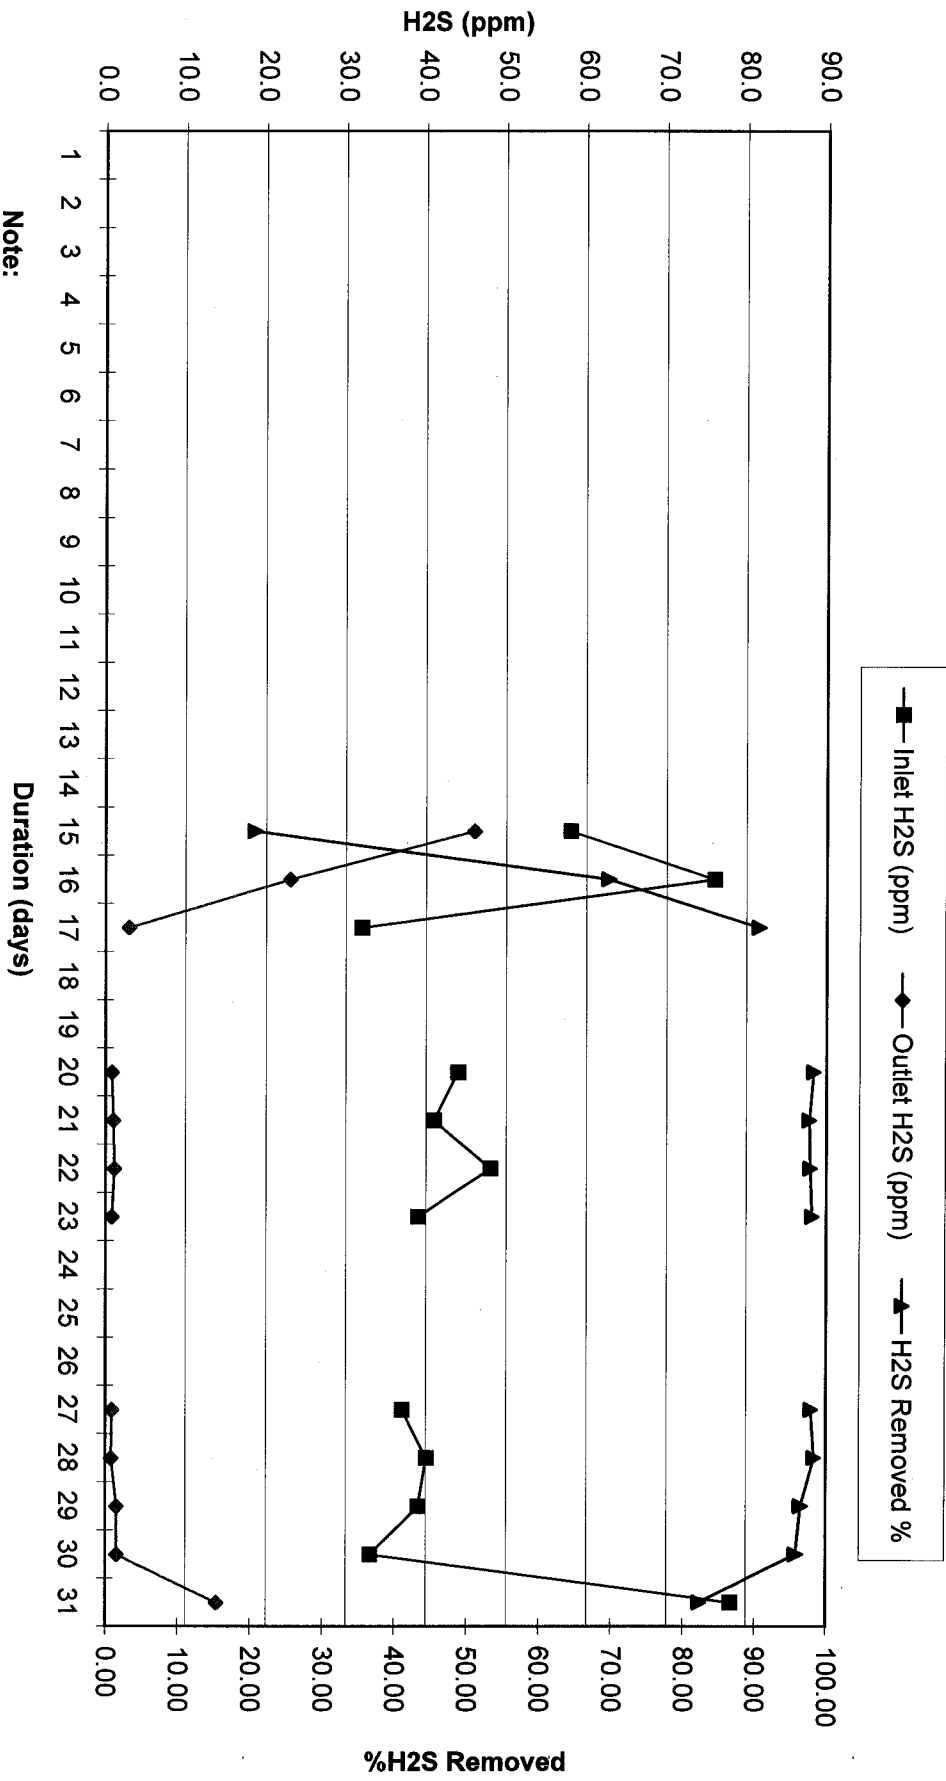
4-Vessels Test Unit - Lava Rock Media July 2009

Note:
 June 29- System was shut down due to excessive water in the area caused by running HPE water during last day.
 July 15- The system was started up after the repair work was completed.
